Replace Statutory Plate

Classification Campaign Bulletin **Section/Group** 19 - Labels **Country/Region** EMEA

Year 2019 **Model** Model 3 **Version** LHD

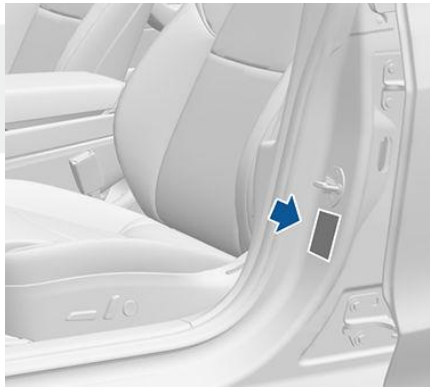
Figure 1

Certain Model 3 vehicles were manufactured with incorrect information on the statutory plate near the base of the driver side B-pillar.

1. Retrieve the updated statutory plate for the vehicle.
2. Check that the VIN on the new statutory plate matches the VIN on the vehicle's dashboard VIN plate.
3. Open the driver's side door.
4. Starting from one corner, carefully peel the statutory plate off the B-Pillar. Discard the statutory plate (Figure 1).

! CAUTION: Take care not to damage the body paint.
